Physical and Bacteriological Quality of Selected Water Sources in Wakiso District, Uganda

*David Musoke,^{1,3}
Miph Boses Musoke,^{2,3}
Abdullah Ali Halage,¹
and John Ssempebwa¹

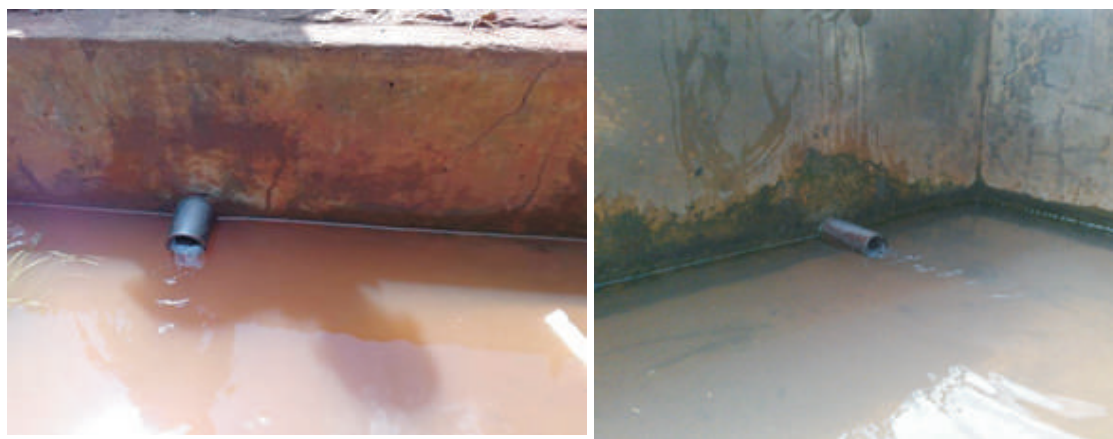
Inspection of the water sources revealed that many protected springs had poor drainage which led to accumulation of waste water in the collection area (Figures 2 and 3) whereas only a few had proper drainage (Figure 4). Human activities were found being carried out at the lake shore including washing clothes and swimming. The unprotected spring was surrounded by bush

Figures 2 and 3: Two protected springs with water stagnated in the collection chamber.

The study established that there was poor drainage at many protected springs leading to accumulation of waste water in the collection chamber sometimes to the level of the spring outlet. This situation poses a major public health concern and is likely to lead to contamination of water during collection from the springs. Water user communities, local authorities and other responsible community members including community health workers should ensure that drainage of waste water at protected springs is improved by unblocking the channels responsible draining the water. The activity of unblocking drainage channels should be done as frequently as the situation at each water source necessitates. Human activity in or near water sources such as washing clothes should be discouraged as it is a potential source of contamination (Pandey *et al*, 2014).

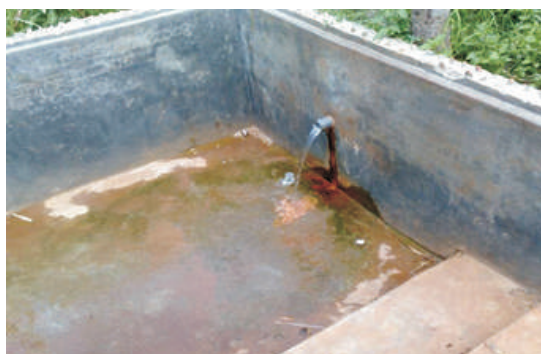
Figure 4: A protected spring with adequate drainage of waste water

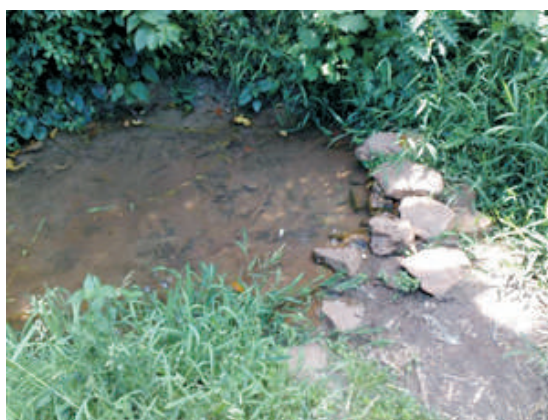
and could easily be contaminated by the water container, hands or feet during the collection process, and animals (Figure 5).

Figure 5: The unprotected spring
